“25 May” primary school – Gazi Baba, Skopje (MK)

Brief Overview

Project Summary:

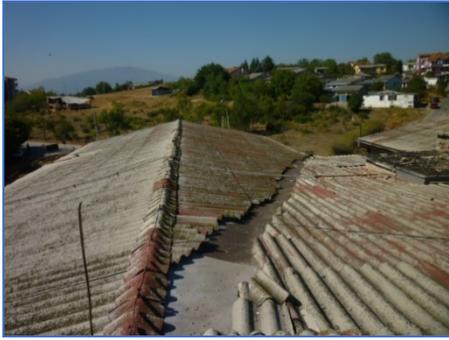
Situation before rehabilitation

Roof replacement: the old roof covering consisted of asbestos cement sheets which were placed onto old wooden structure without any thermic insulation. Over time, asbestos disintegrates and toxic dust is released, thereby causing numerous health issues due to the exposure to asbestos, dust or fibers.

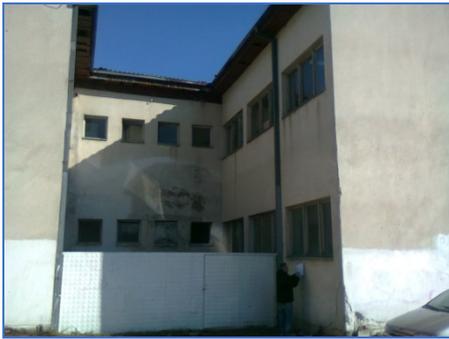
Situation before rehabilitation

Renovation of facades and replacement of windows: the old facades were not thermally insulated and the old window frames needed to be replaced to ensure proper thermal insulation.

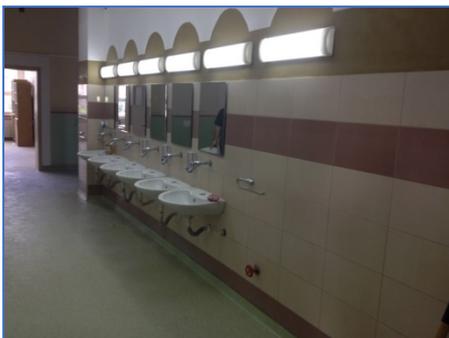
Rehabilitation of toilets and sanitary elements: conditions of the old toilets, pipes and sinks were sub-standard and required a complete rehabilitation/replacement.

Replacement of plumbing and sinks

Results achieved: rehabilitation works included total replacement of plumbing, sewage pipes, electrical installation, sanitary elements as well as tiles and doors. Moreover, a completely new toilet for disabled students was installed.

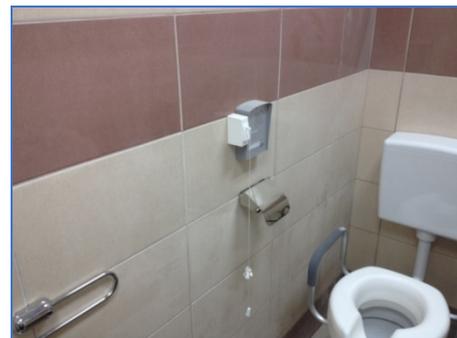
Installation of toilets for disabled students

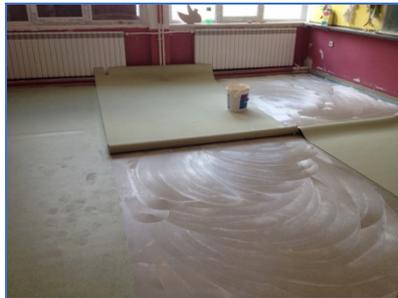
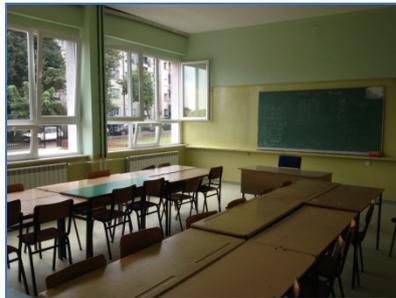
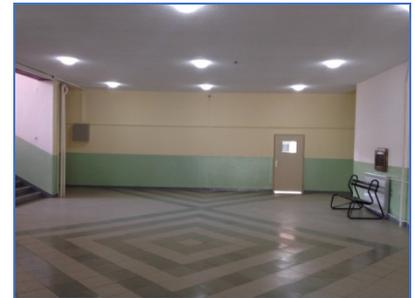
Replacement of floor surfaces: as a result of a prolonged lack of maintenance, all the building's floor surfaces required renovation/replacement.

Results achieved: on the ground floor, rehabilitation works included complete thermal insulation by using polystyrene and cement (installation of a 6 cm thick layer). PVC stripes were installed in the classrooms onto the previously prepared contact surface, and ceramic tiles were placed in the corridors. PVC stripes were also installed in the first floor's classrooms and corridors.
